RCRA Facility Investigation (RFI) Phase I Report

**Waste Management of Ohio, Inc.
Vickery, Ohio**

U.S. EPA ID No. OHD 020 273 819

October 1999

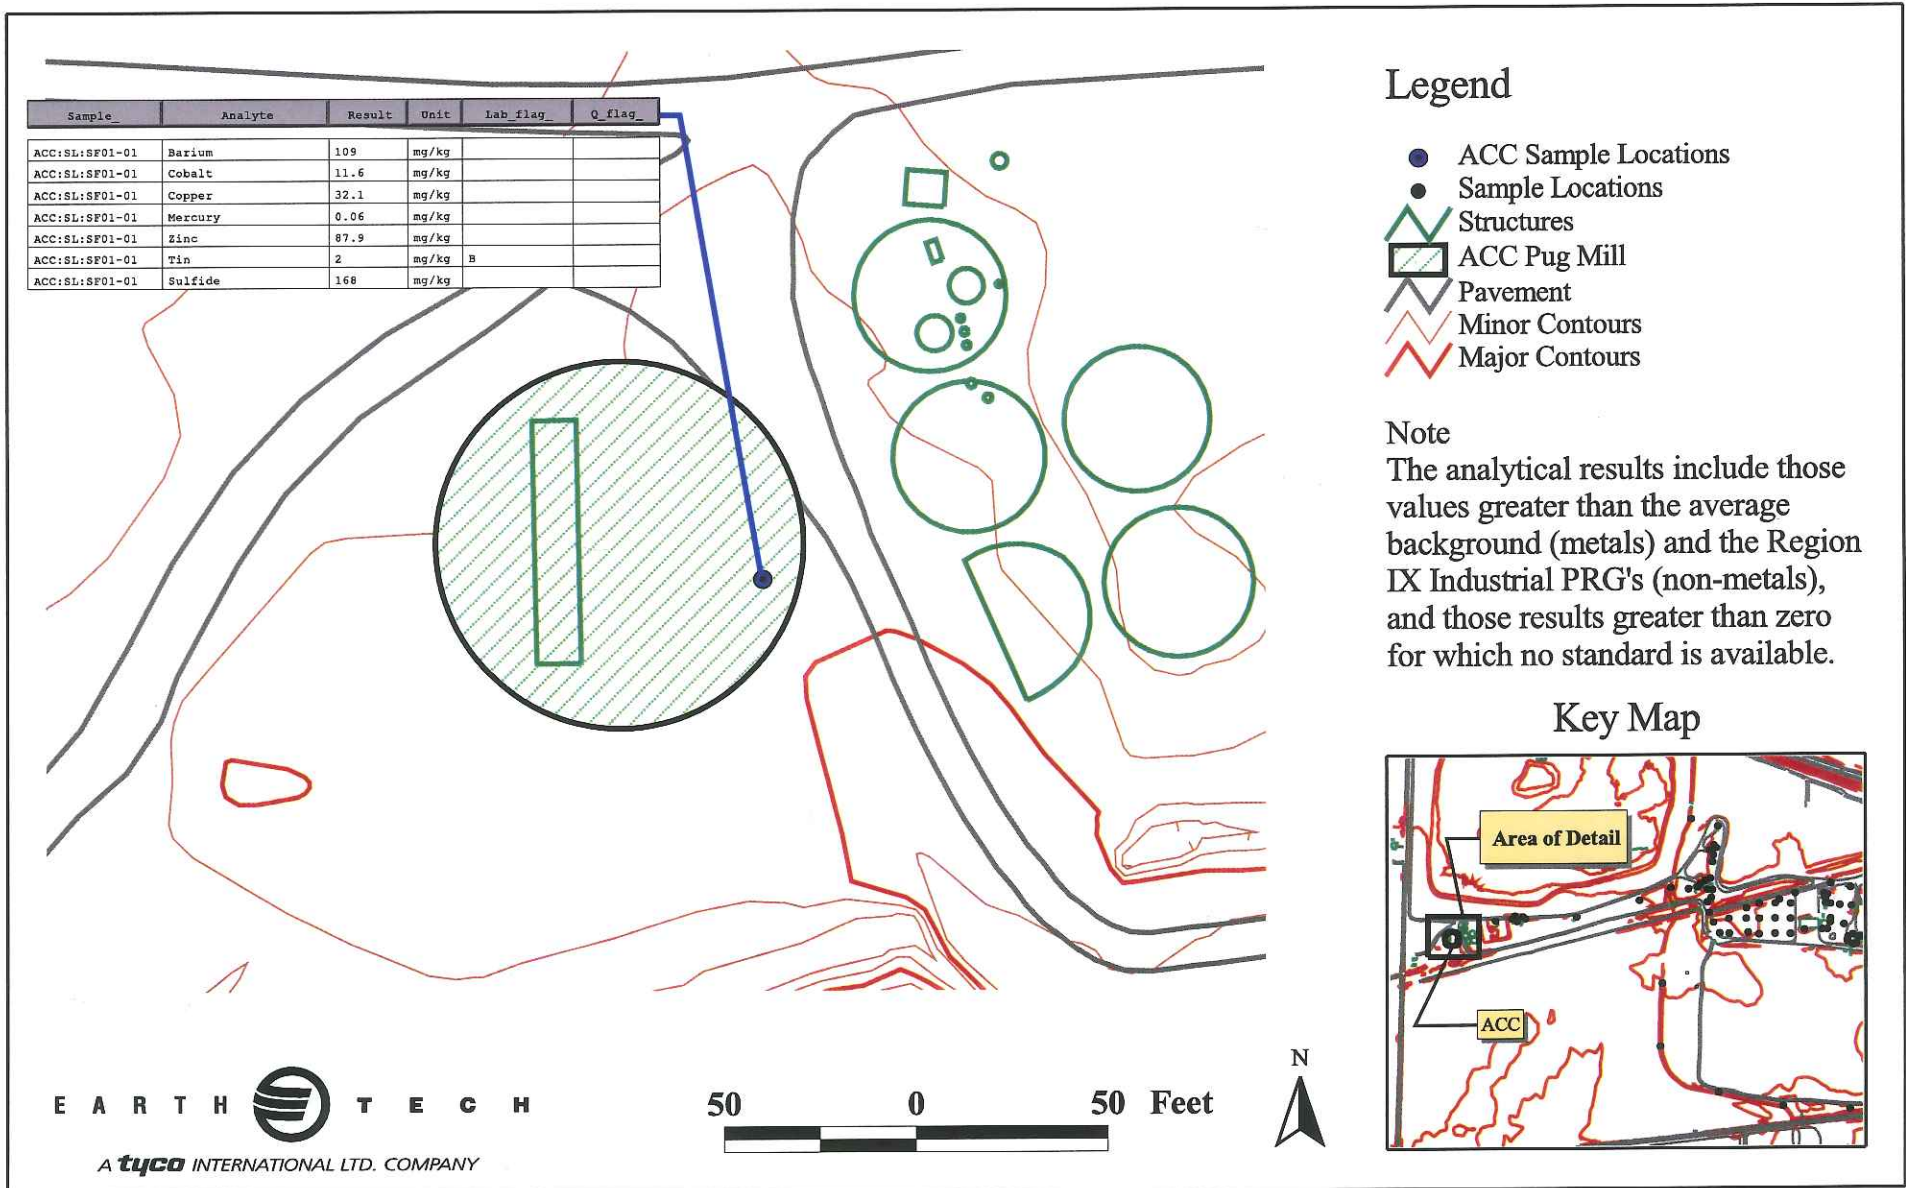
Figure 5-4.3
Area of Concern C Pug Mill Analytical Results Map
Waste Management of Ohio - Vickery

Soil samples collected to characterize the area where the Pug Mill was stored after it was decontaminated do not contain any of the potential contaminants, except for arsenic, above PRGs. The arsenic detection is interpreted as representing naturally occurring conditions.

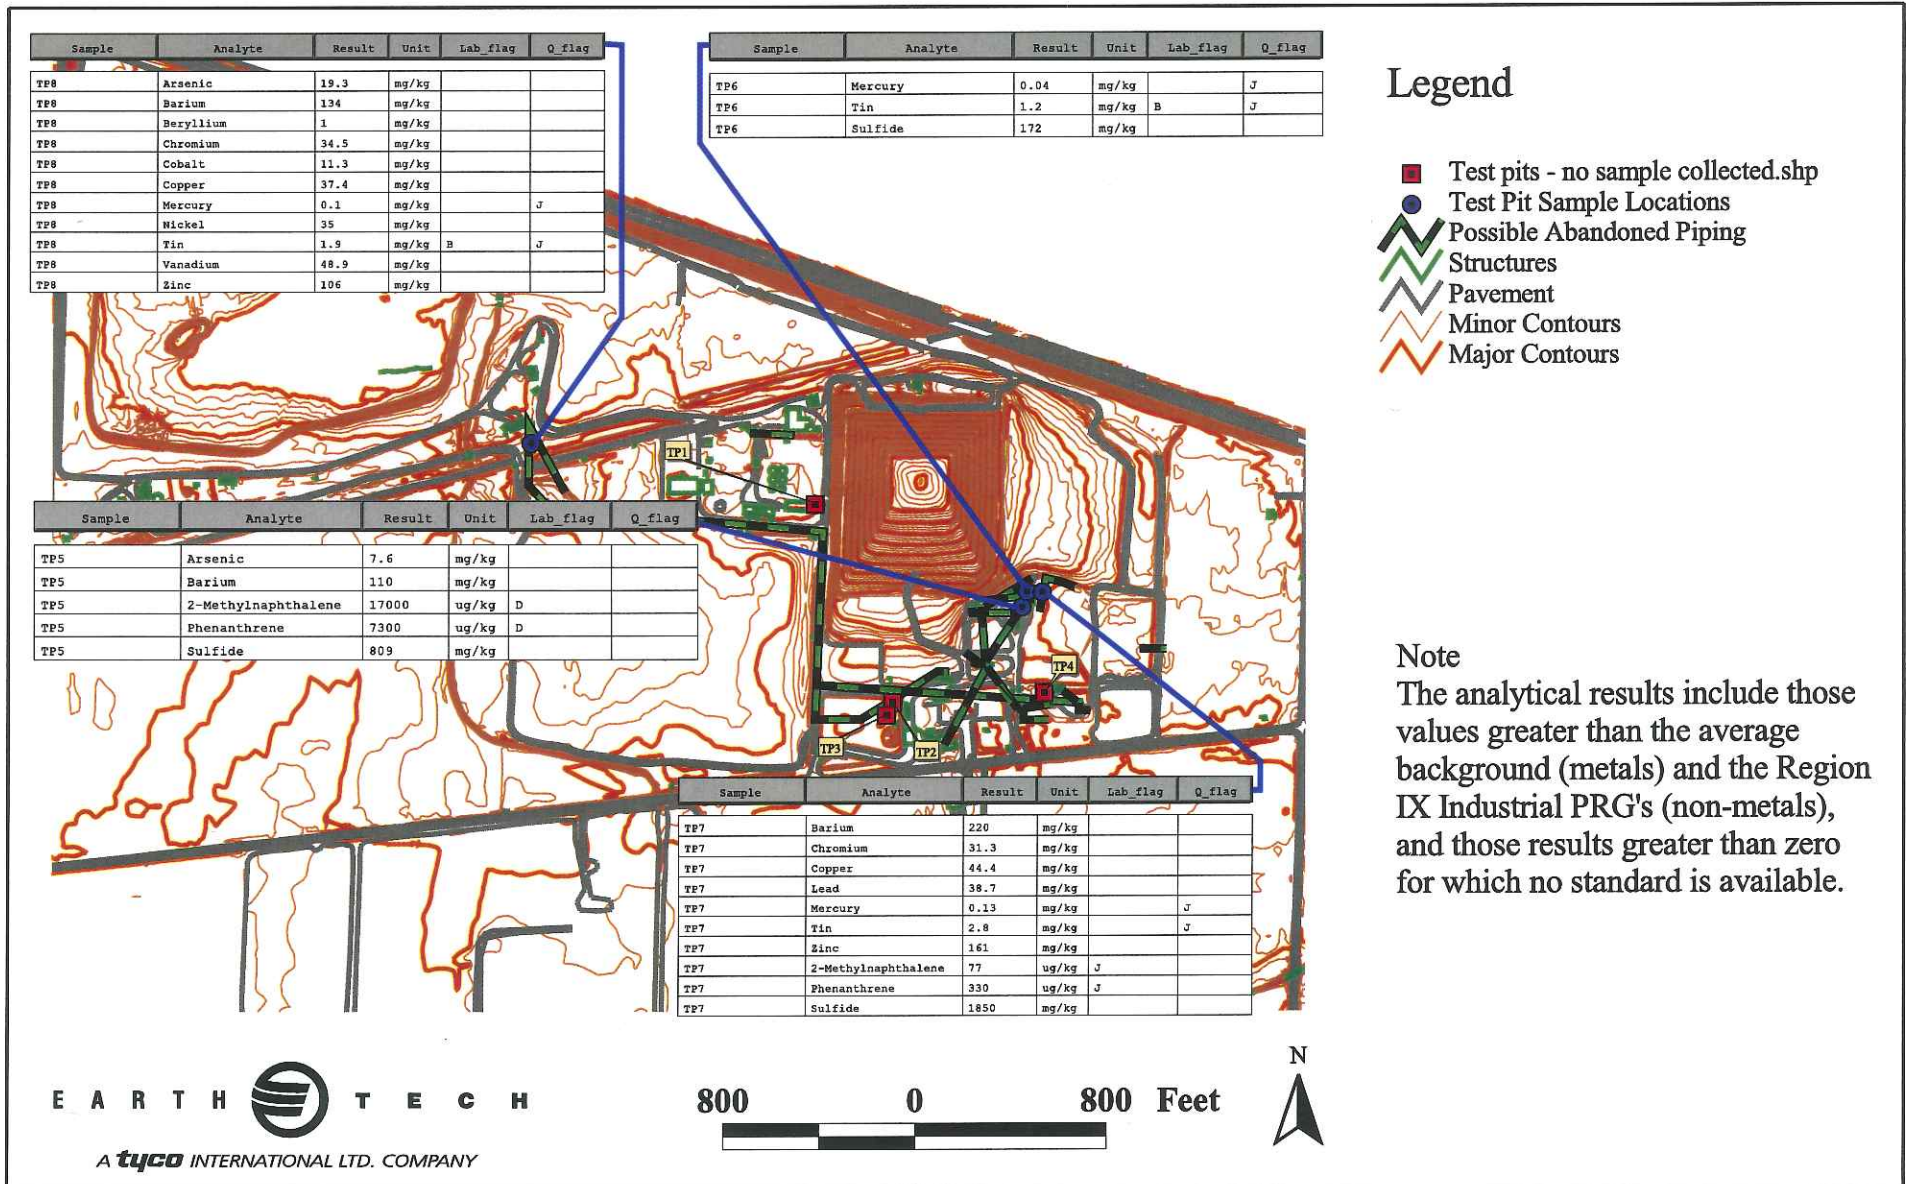
Figure 5-4.9
Area of Concern I Analytical Results Map
Waste Management of Ohio - Vickery

Geophysical methods used to determine the presence of abandoned underground piping were inconclusive; therefore, test pits were excavated to directly observe evidence of underground piping. No piping was found in four test pits. Evidence of former underground piping and/or potential contamination was observed in three test pits. Underground piping was also exposed in a trench beneath an aboveground pipeline. However, samples collected from these test pits showed no exceedences of applicable standards, except for arsenic. Several of the target metal concentrations were exceeded in these samples, but none were above the corresponding PRGs. As explained above, these results are interpreted as representative of natural conditions and do not indicate impact from the former piping.
